Demonstration and Validation of Two-Coat High-Performance Coating System for Steel Structures in Corrosive Environments

Final Report on Project F12-AR06

Brooke A. Divan, Richard G. Lampo, Susan A. Drozdz, Christopher Olaes, and Larry Clark December 2016

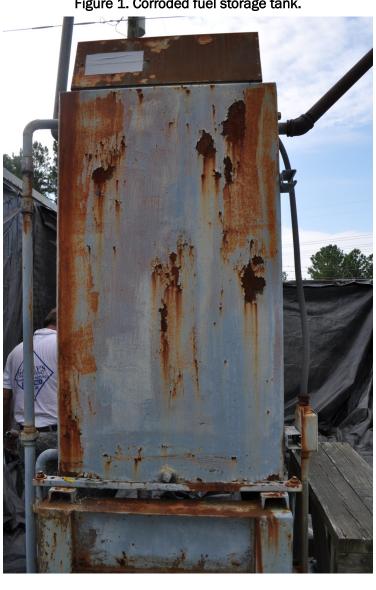
Figure 1. Corroded fuel storage tank.

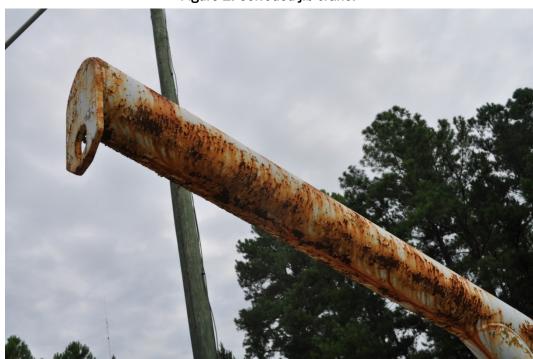
Figure 2. Corroded jib crane.

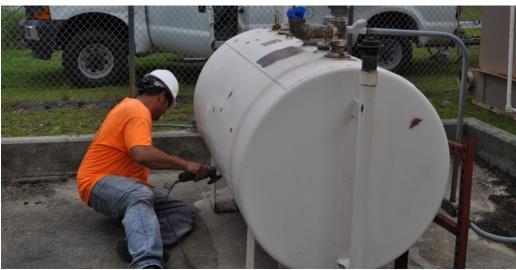
Figure 4. Hand tool corrosion removal.

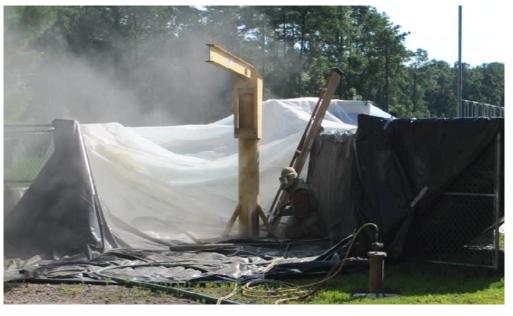
Figure 5. Abrasive blasting of jib crane.

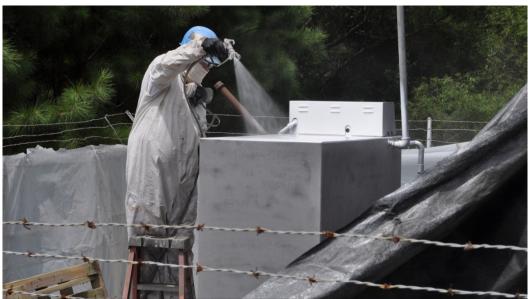
Figure 6. Applying epoxy barrier coat.

The A and B components of the epoxy barrier coat in the two-coat high-performance paint system require mechanical agitation prior to mixing due the high viscosity of the coatings. The two components of the epoxy are mixed at a 1:1 ratio, and then they require mechanical agitation for 3–5 minutes. Once mixed, the coating must be applied immediately due to the short pot life (Figure 6). As stated previously, the small size of the fuel tanks and cranes allowed them to be painted within the pot life of the coating.

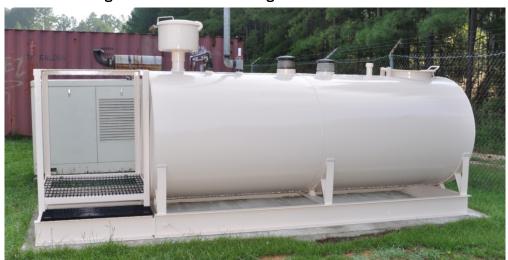
Figure 7. Finished fuel storage tank at Lift Station 7.

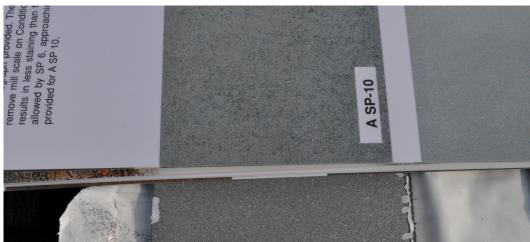
Figure 9. SSPC VIS 1 comparison with coupon.

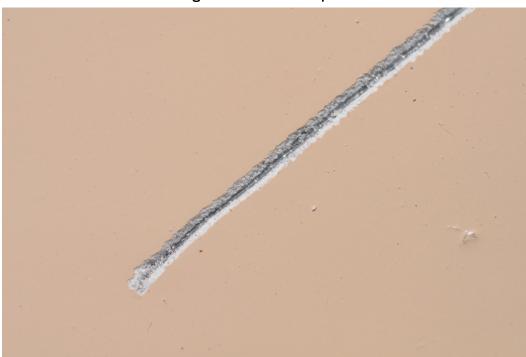
Figure 11. Scribed coupon.

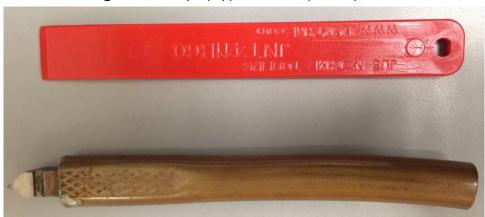
Figure A1. Scrape (top) and scribe (bottom) tools.

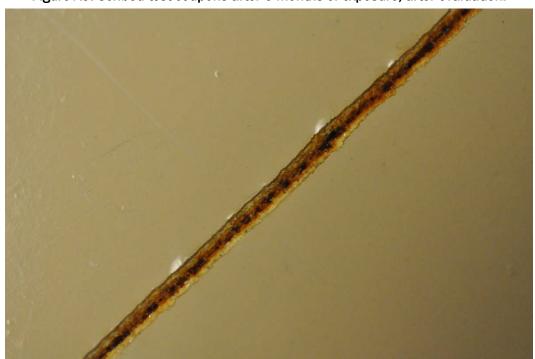
The results of the evaluation are listed in Table 1. It was observed that no creep existed from the scribed coupons (rating of 10 per ASTM D1654), and there was no failure of the coating in terms of rust or blisters on either the coupon or the structures.

Figure A5. Scribed test coupons after 6 months of exposure, after evaluation.

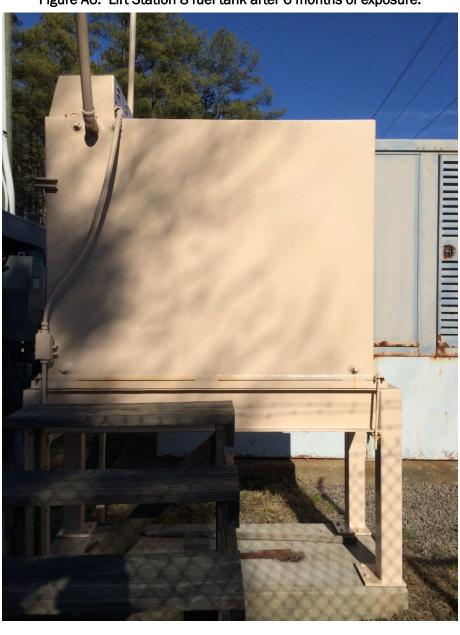
Figure A6. Lift Station 8 fuel tank after 6 months of exposure.

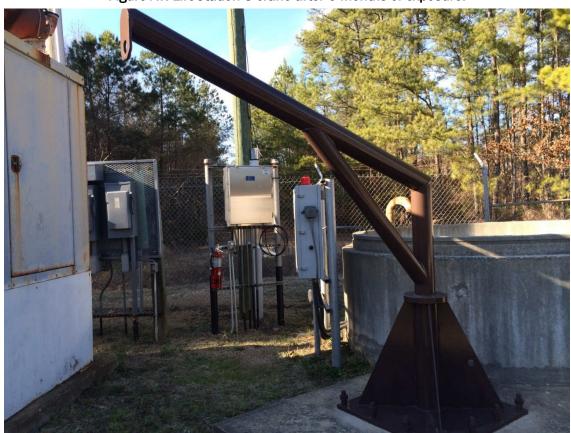
Figure A7. Lift Station 8 crane after 6 months of exposure.

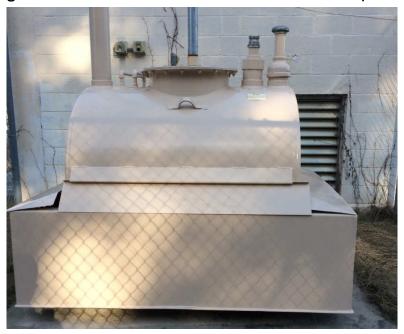
Figure A9. Lift Station 11 crane after 6 months of exposure.

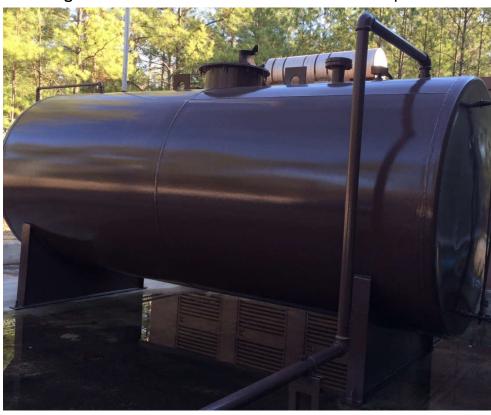
Figure A10. Lift Station 1 fuel tank after 6 months of exposure.

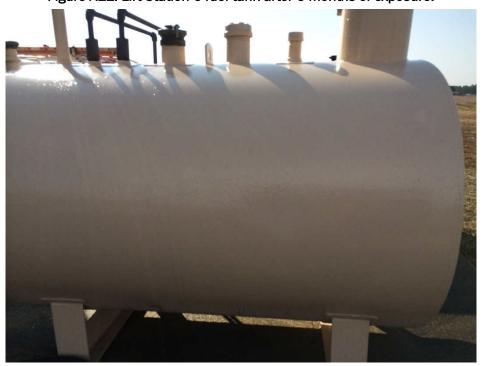
Figure A12. Lift Station 9 fuel tank after 6 months of exposure.

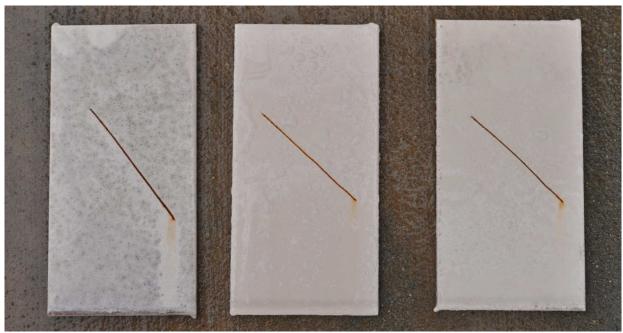
A test coupon on the exposure rack was evaluated in accordance with ASTM Test Method D 1654 on 6 August 2014, with approximately 12 months of exposure. Prior to exposure, the coupon was scribed and placed on an exposure rack at Fort Bragg, NC. The exposure rack was positioned 45 degrees from horizontal. Procedure A, Method 2 was used to evaluate the scribe. The unscribed areas were evaluated using procedure B which references ASTM D714 and ASTM D610. The performance of the coatings on the structures were evaluated in accordance with ASTM D1654, Procedures B and D. The results of the evaluation are listed in Table B1 and Figures B1–B13. It was observed that approximately 0.5 mm of creepage existed from the scribed coupons, and there was no failure of the coating in terms of rust or blisters on either the coupon or structures.

Figure B1. Scribed test coupons after 12 months of exposure.

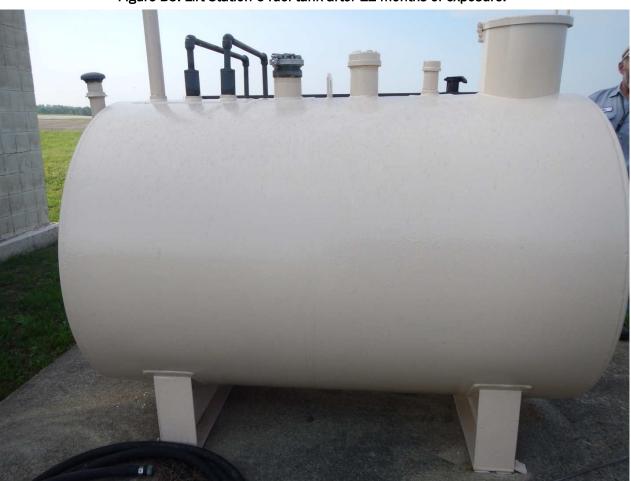
Figure B5. Lift Station 6 fuel tank after 12 months of exposure.

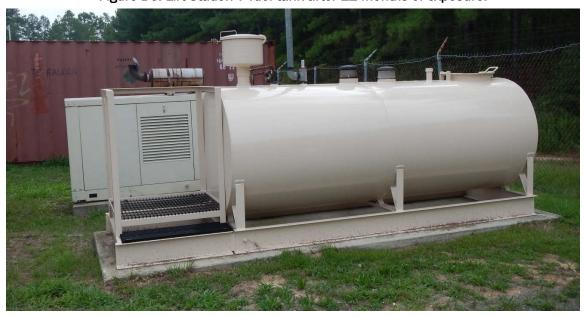
Figure B7. Lift Station 8 fuel tank after 12 months of exposure.

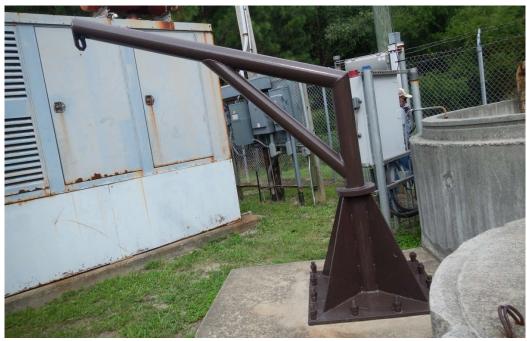
Figure B8. Lift Station 8 jib crane after 12 months of exposure.

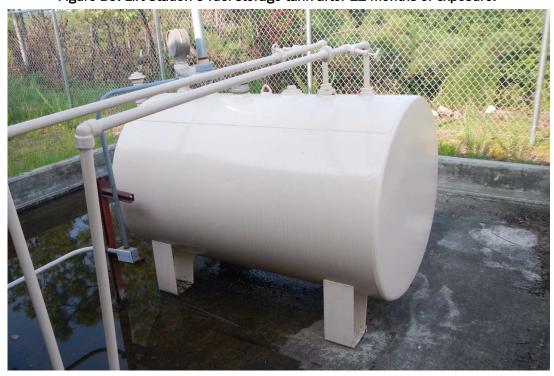
Figure B9. Lift Station 9 fuel storage tank after 12 months of exposure.
